WHITE MEADOW LAKE DAM

NJ 00340

**PHASE 1 INSPECTION REPORT
NATIONAL DAM SAFETY PROGRAM**

August, 1979

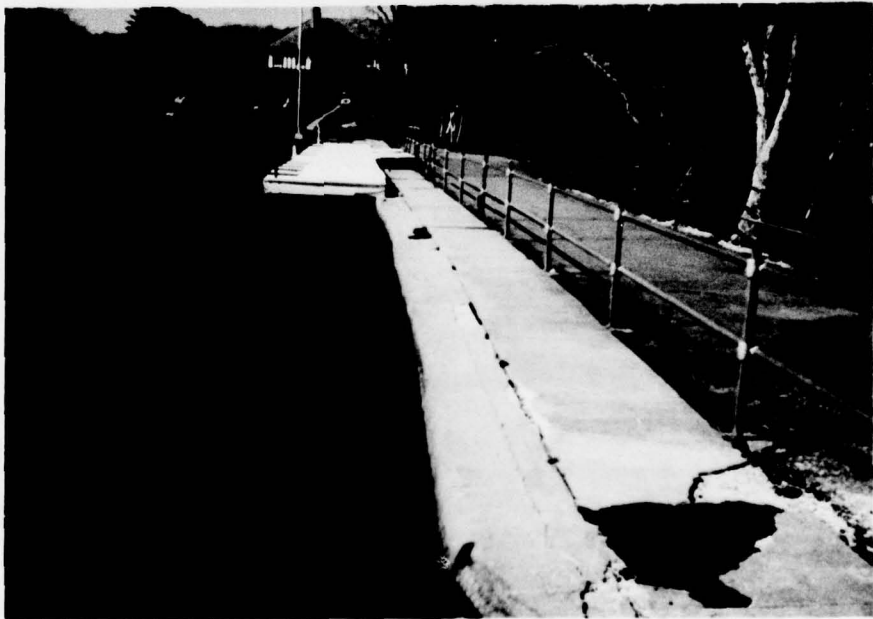
PHOTO 4

The concrete wall comprising the upstream face of embankment is in generally adequate condition. The south section of wall appears to have a "shotcrete" surface. The construction joint between the wall and the concrete pavement is in generally satisfactory condition with some separation noted along the south section.

UPSTREAM FACE OF DAM
